## AGARD ADVISORY REPORT 308

### Propulsion and Energetics Panel Working Group 20

### Test Cases for Engine Life Assessment Technology

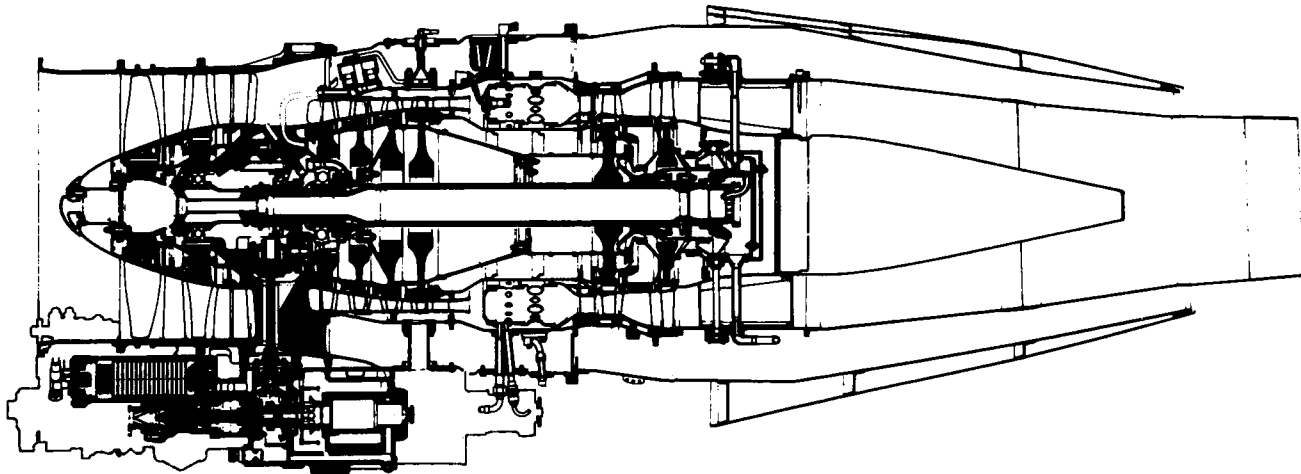
**Figure 2.1 LARZAC ENGINE**

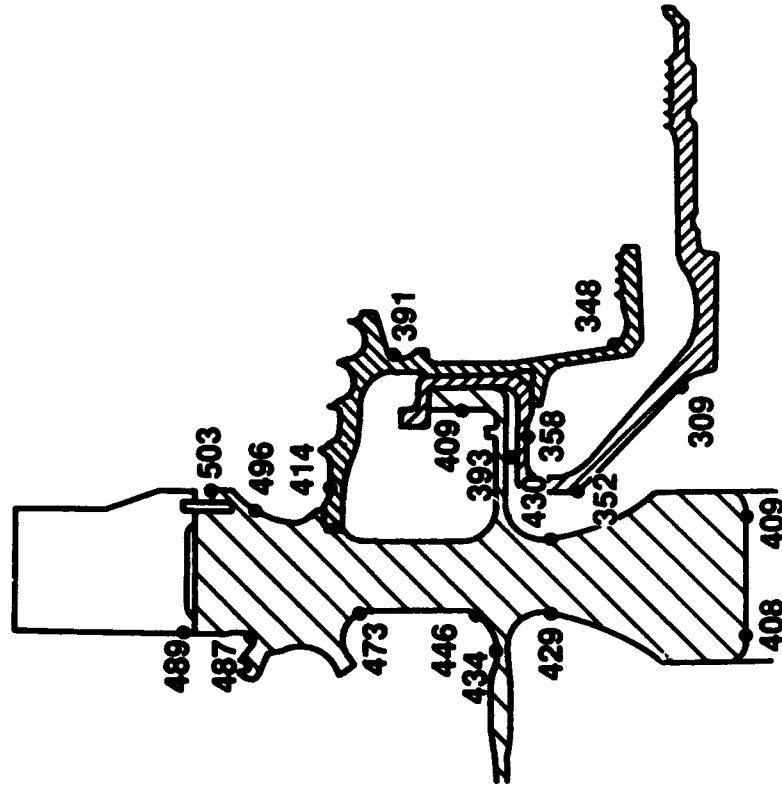
Figure 5.2 BOUNDARY CONDITIONS FOR STRESS ANALYSIS

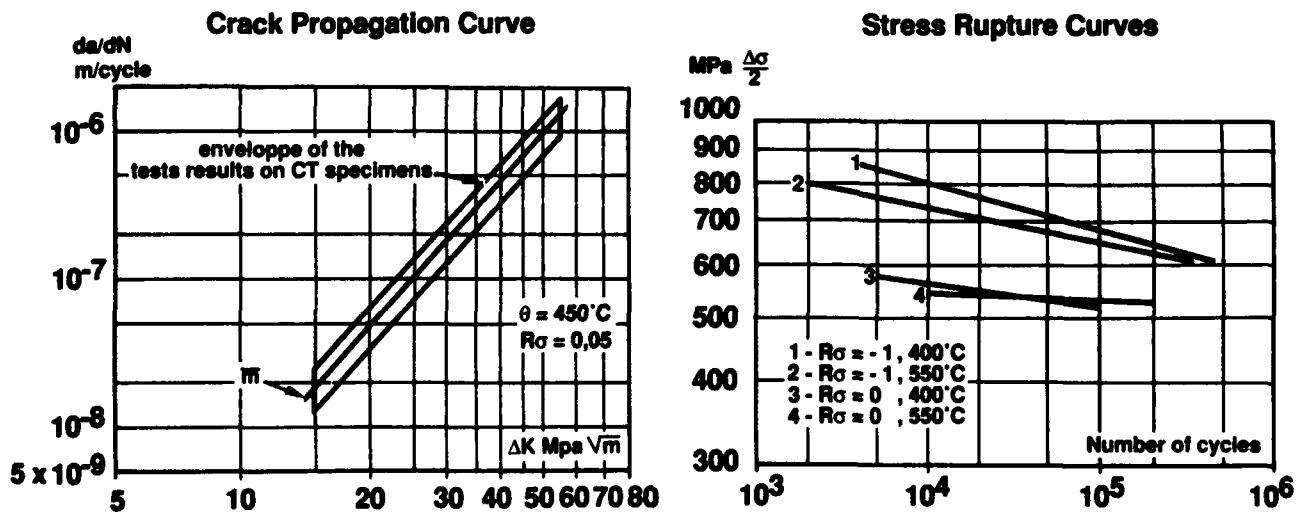
Figure 7.4 L.C.F. DATA INCONEL 718

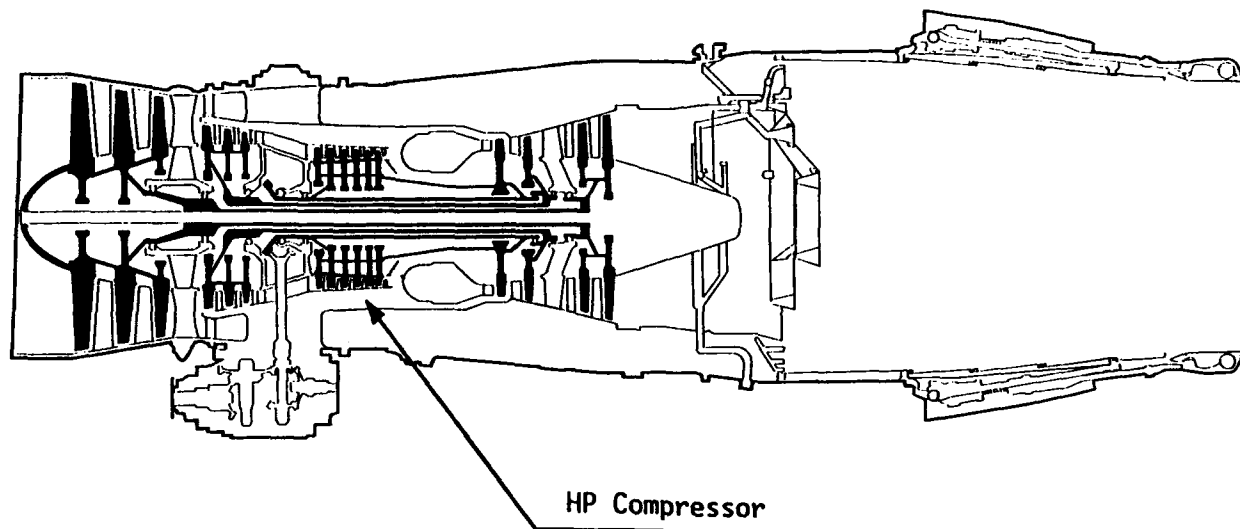
Fig. 2 : Cross Section of HP Compressor

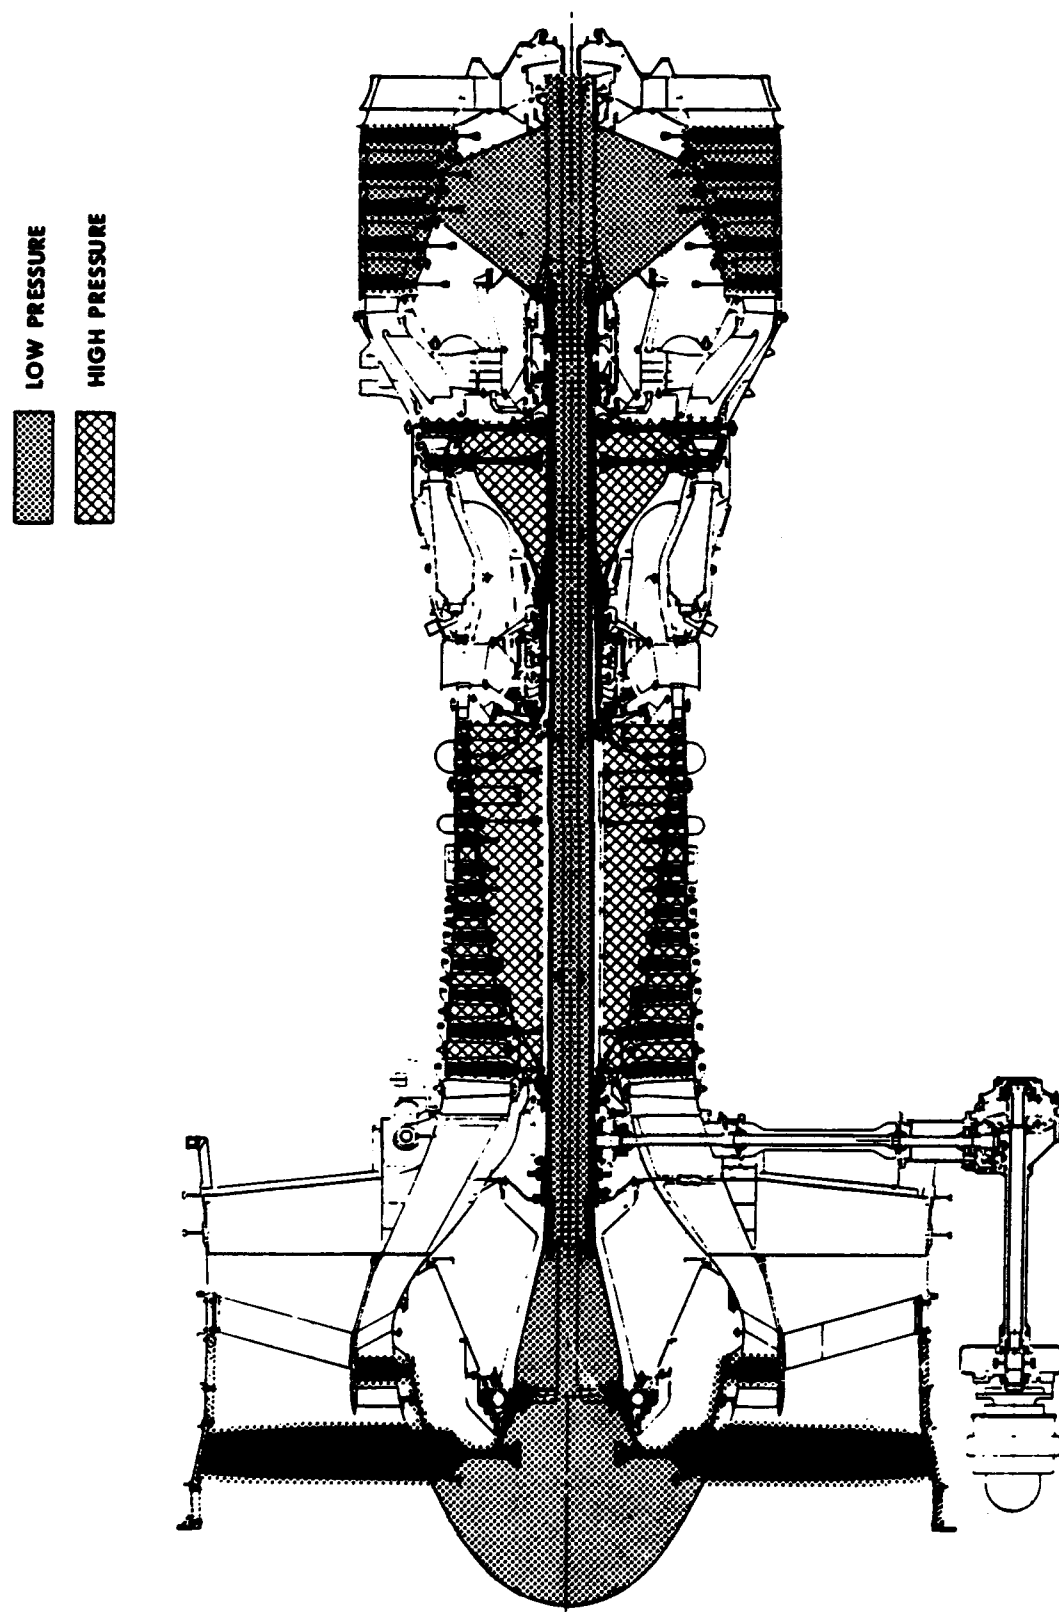
Figure 1 CF6-6 rotating assemblies.

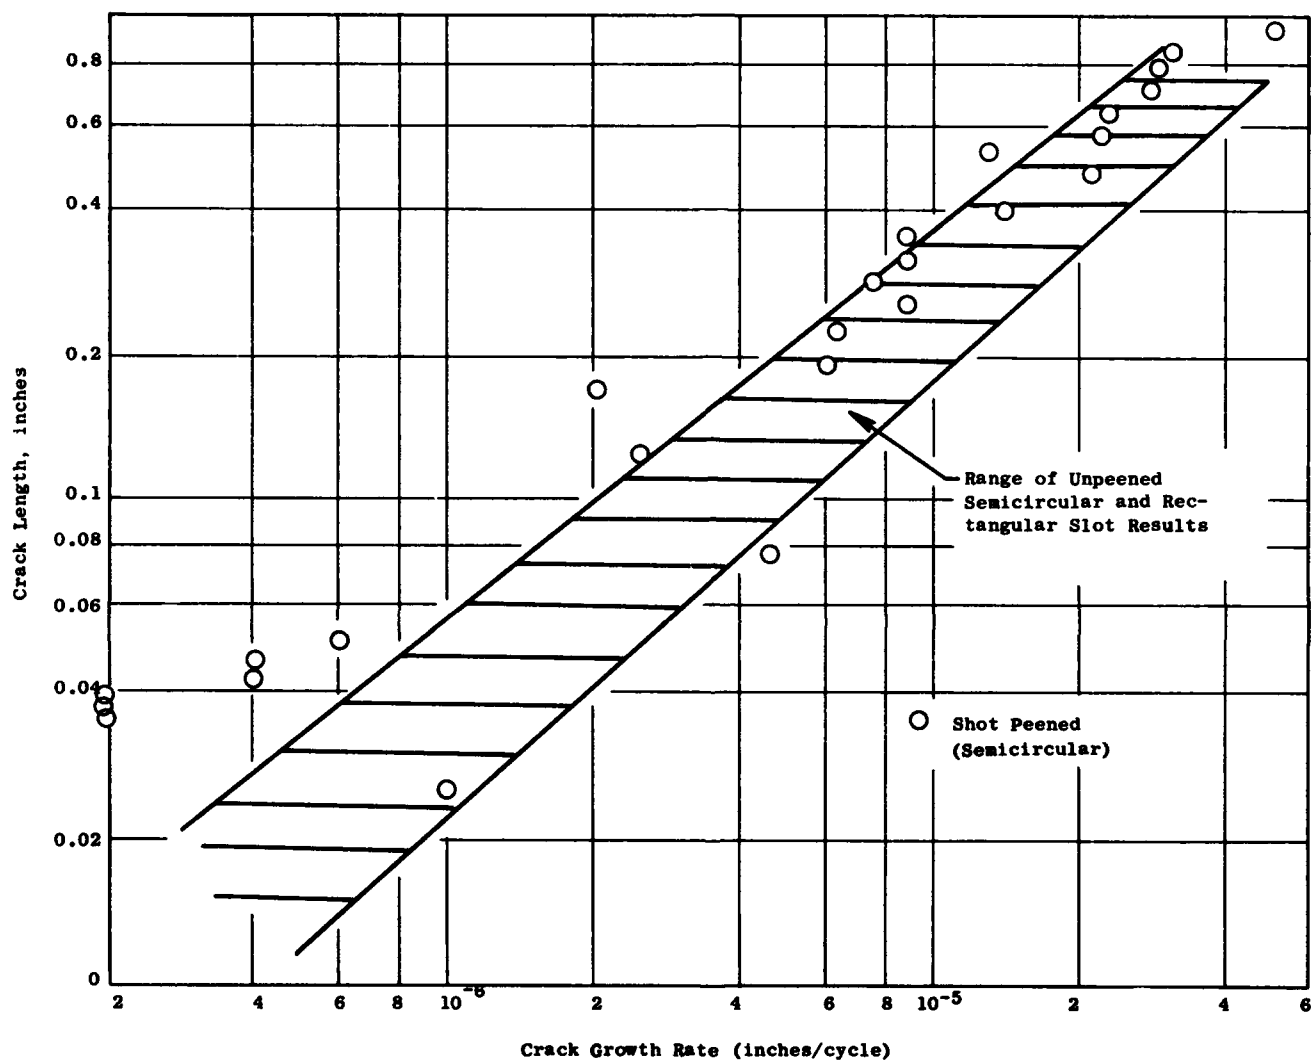
Figure 8 Shot peen plate crack growth rate comparison.

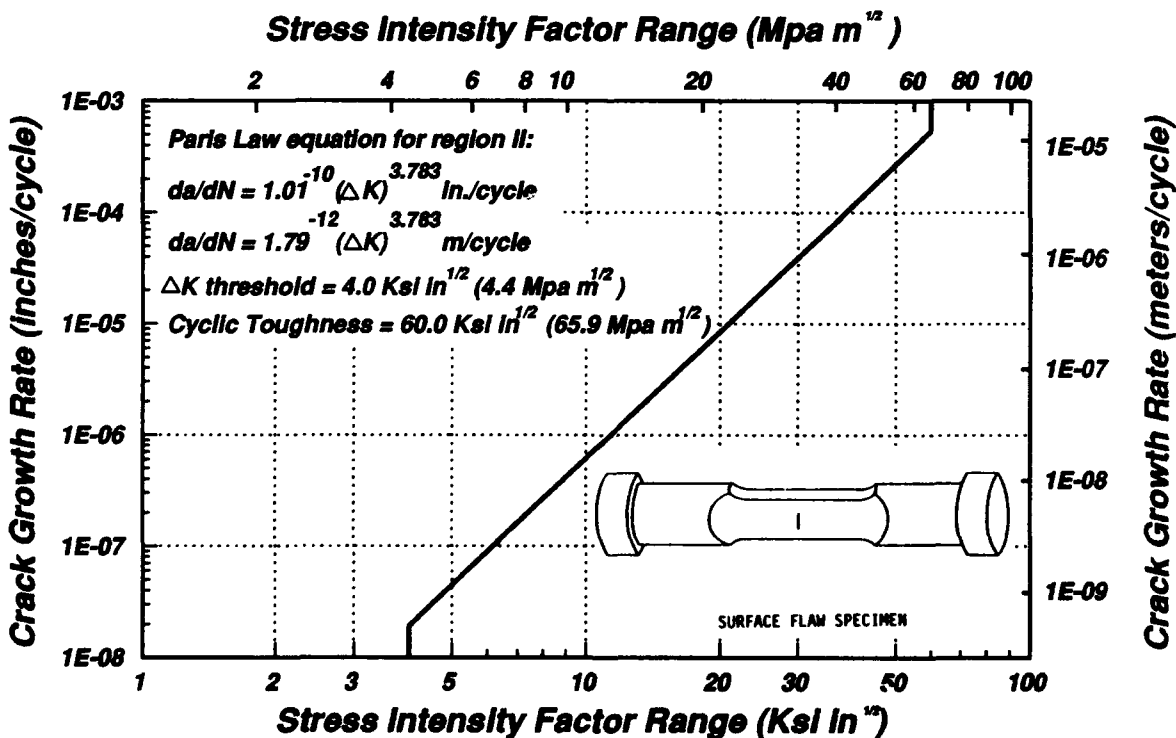
Figure 11 Cyclic crack growth rate data.

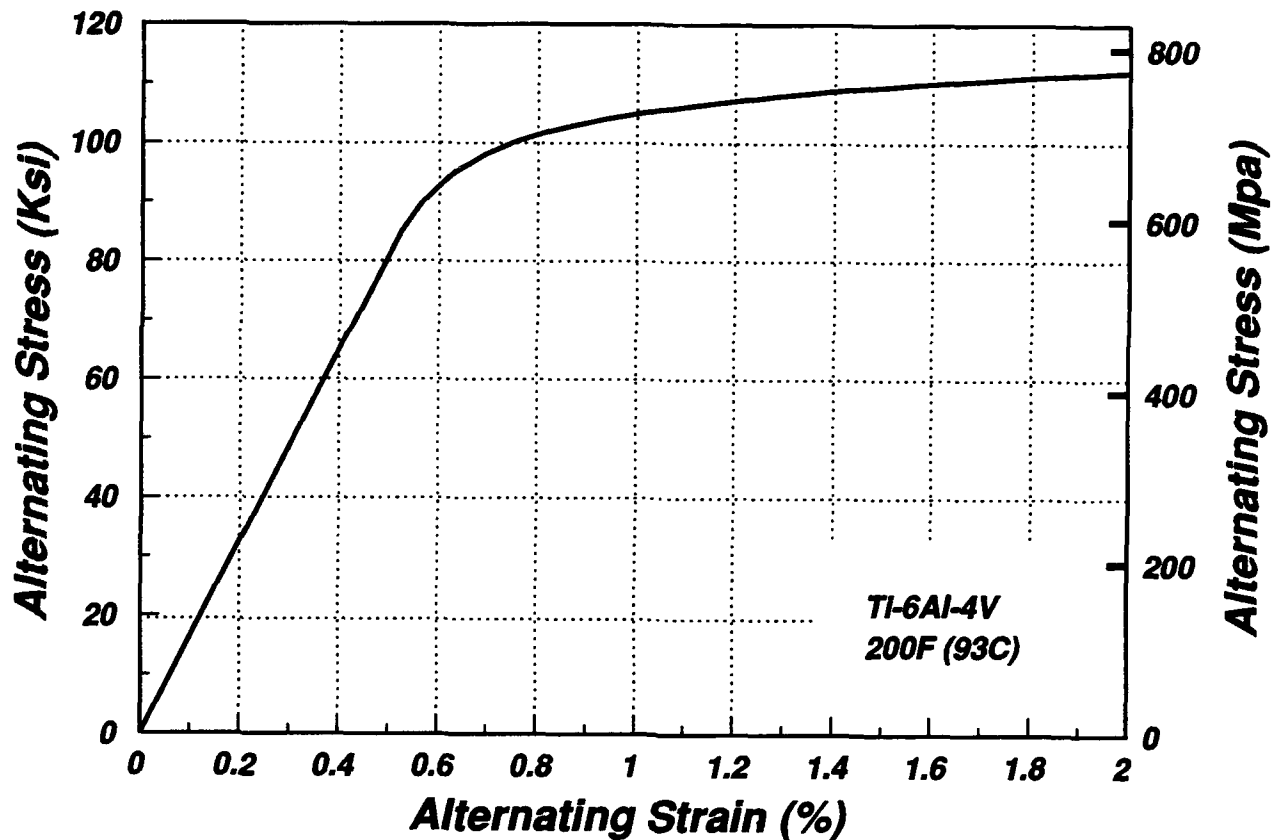
Figure 12 TI 6-4 Cyclic stress-strain curve (at  $N_f/2$ ).

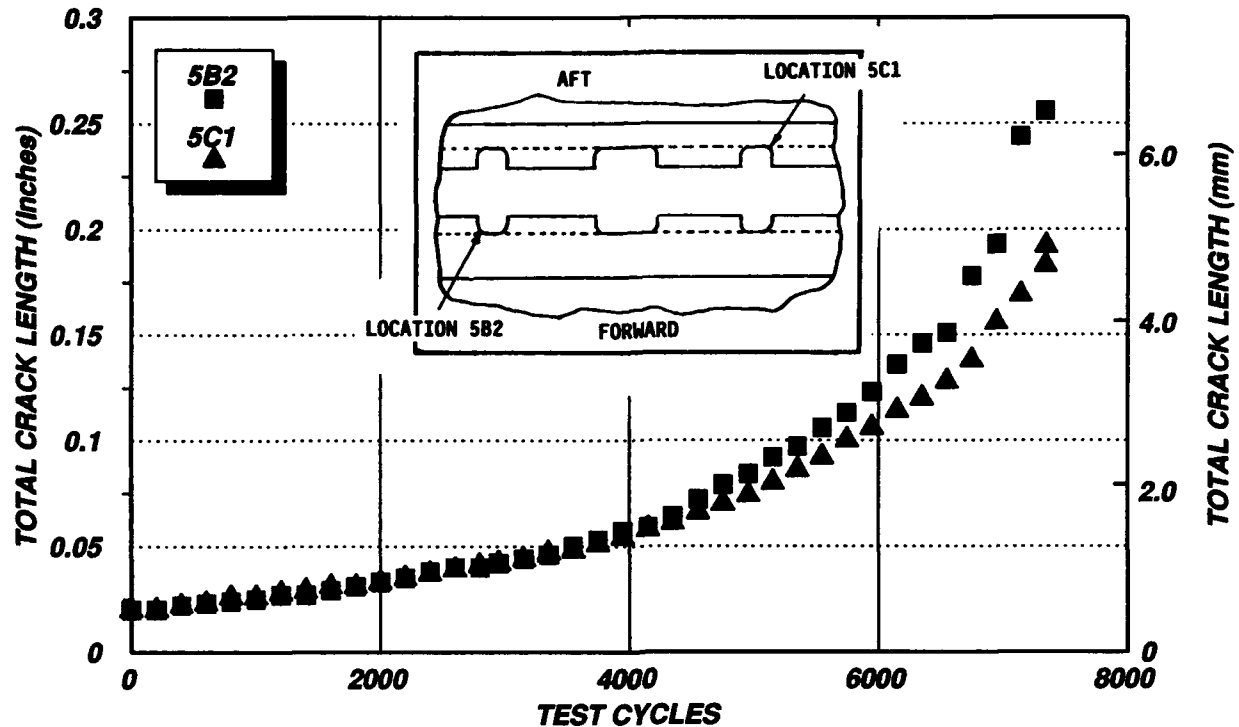
Figure 14 Spin pit crack propagation results.

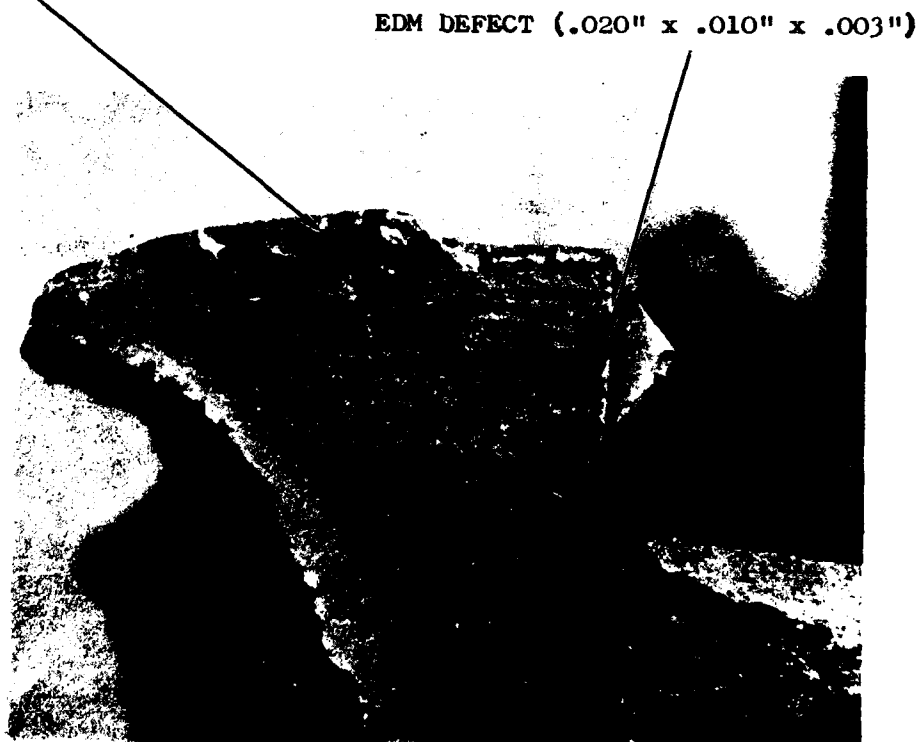
Figure 16 Stage 5 locking slot fracture surface.

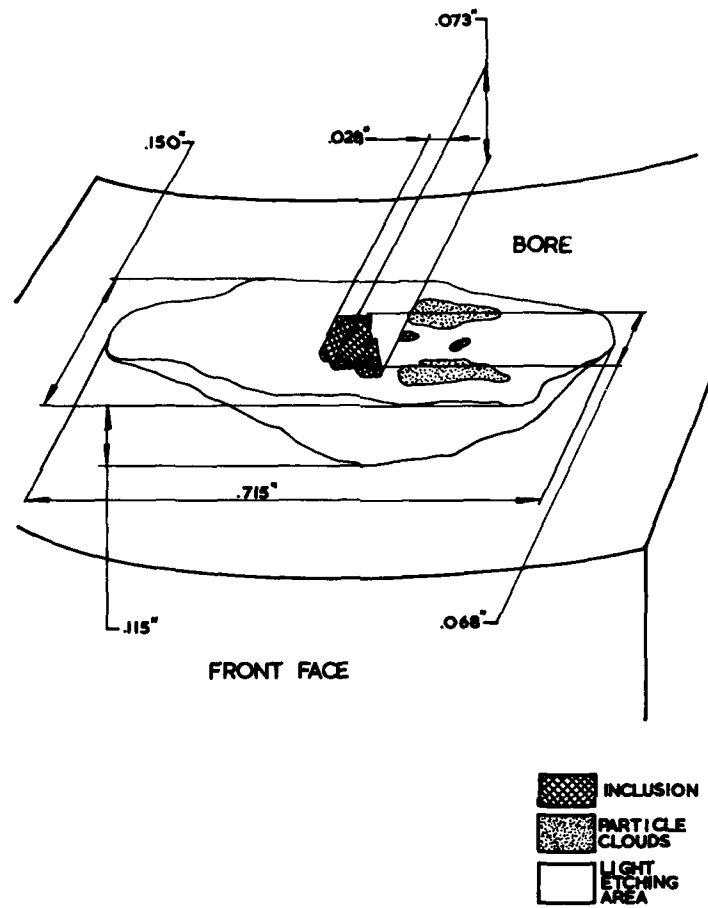
Figure 26

Rig test — Waspaloy disc test  
Fatigue cracking initiating at an inclusion

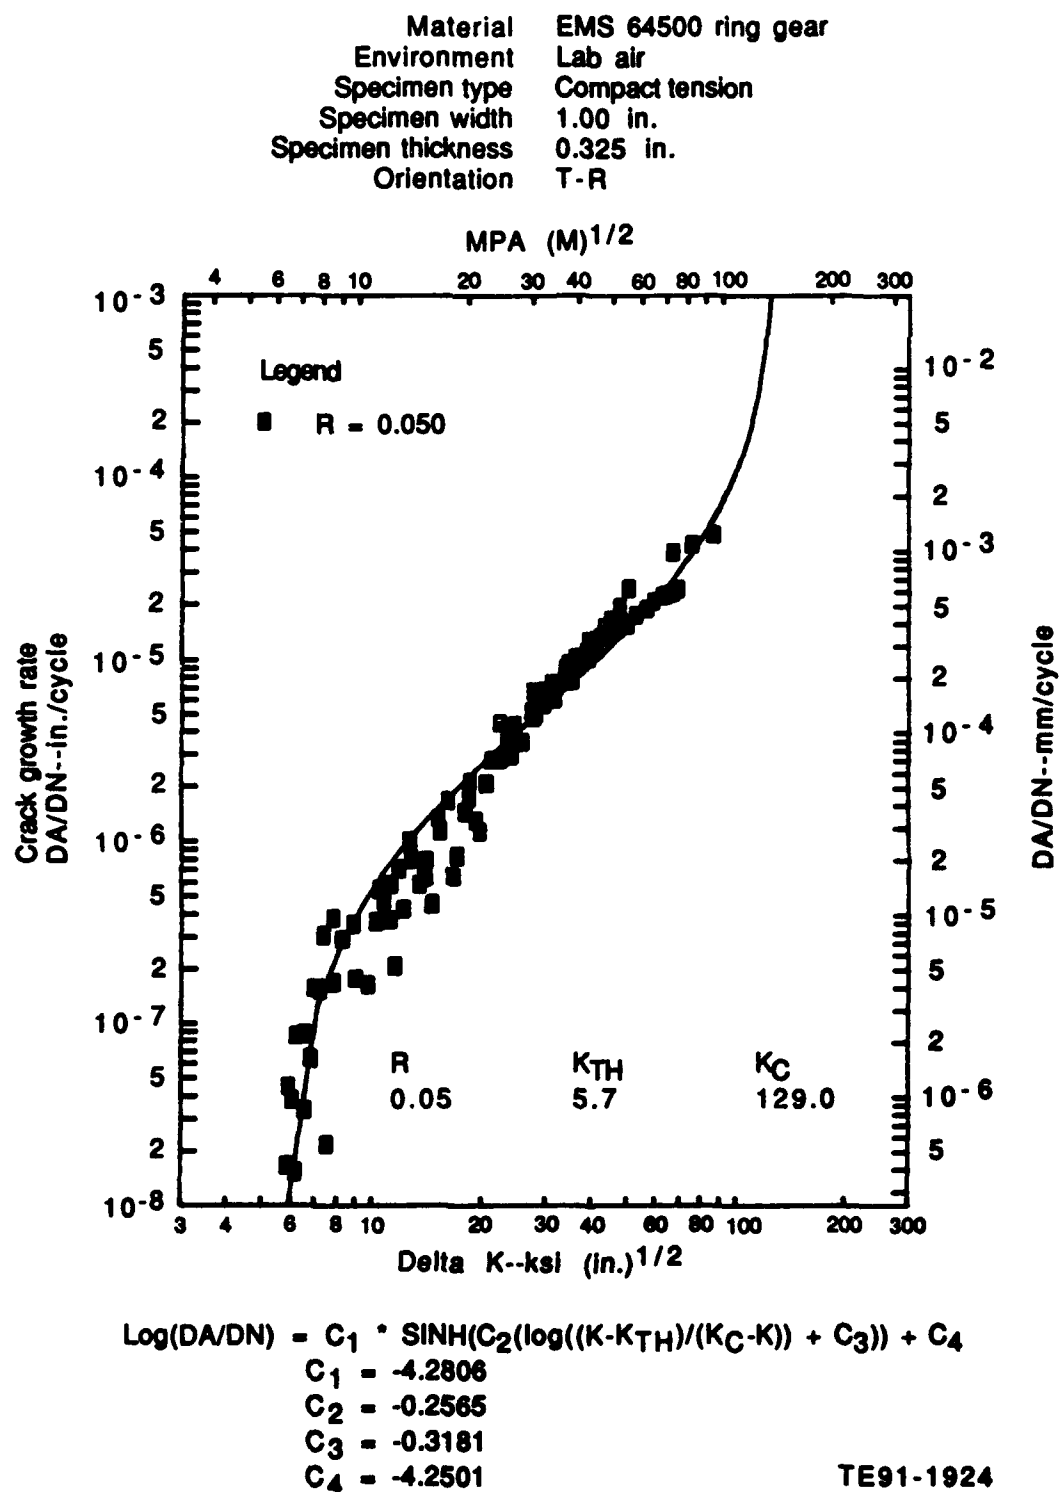
Fig. 7-34. Fatigue crack growth of EMS 64500 at 200°F - compact tension.

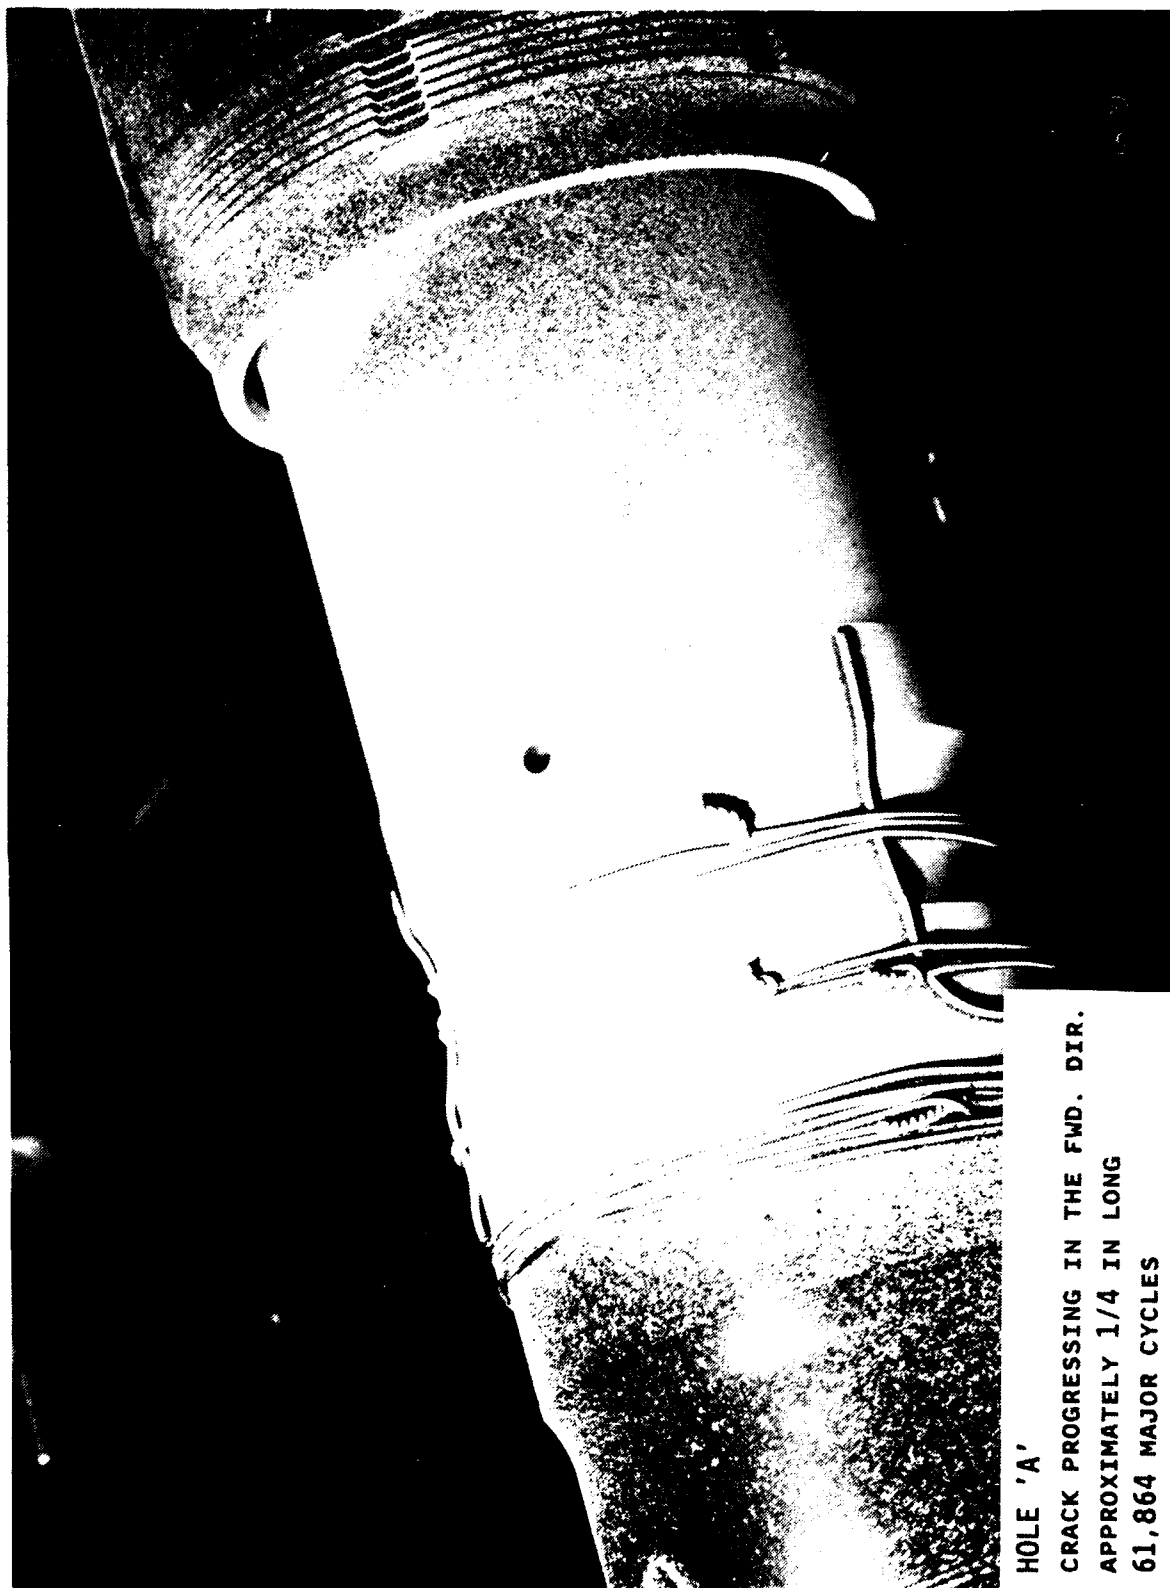
Fig. A-1. Hole 'A'--crack progressing in the forward direction; approximately 1/4 in. long. 61,864 major cycles. (Part 1 of 2)

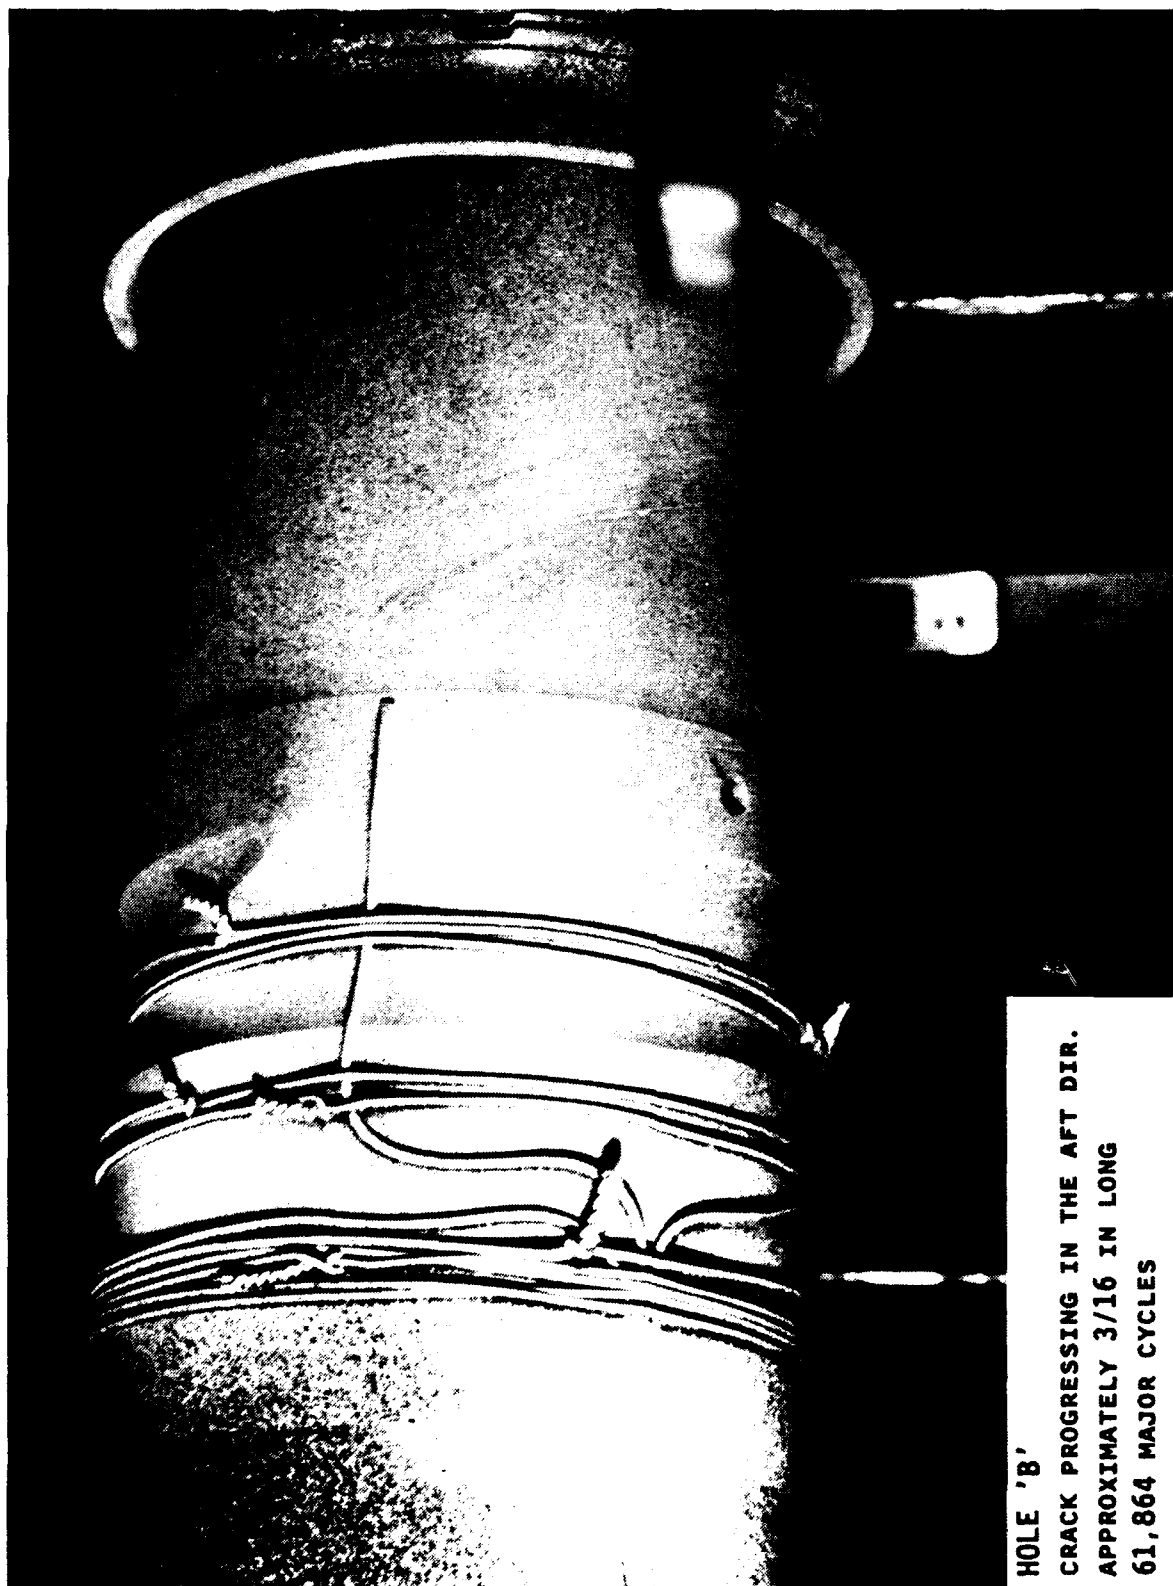
Fig. A-2. Hole 'B'--crack progressing in the aft direction; approximately 3/16 in. long, 61,864 major cycles. (Part 1 of 2)

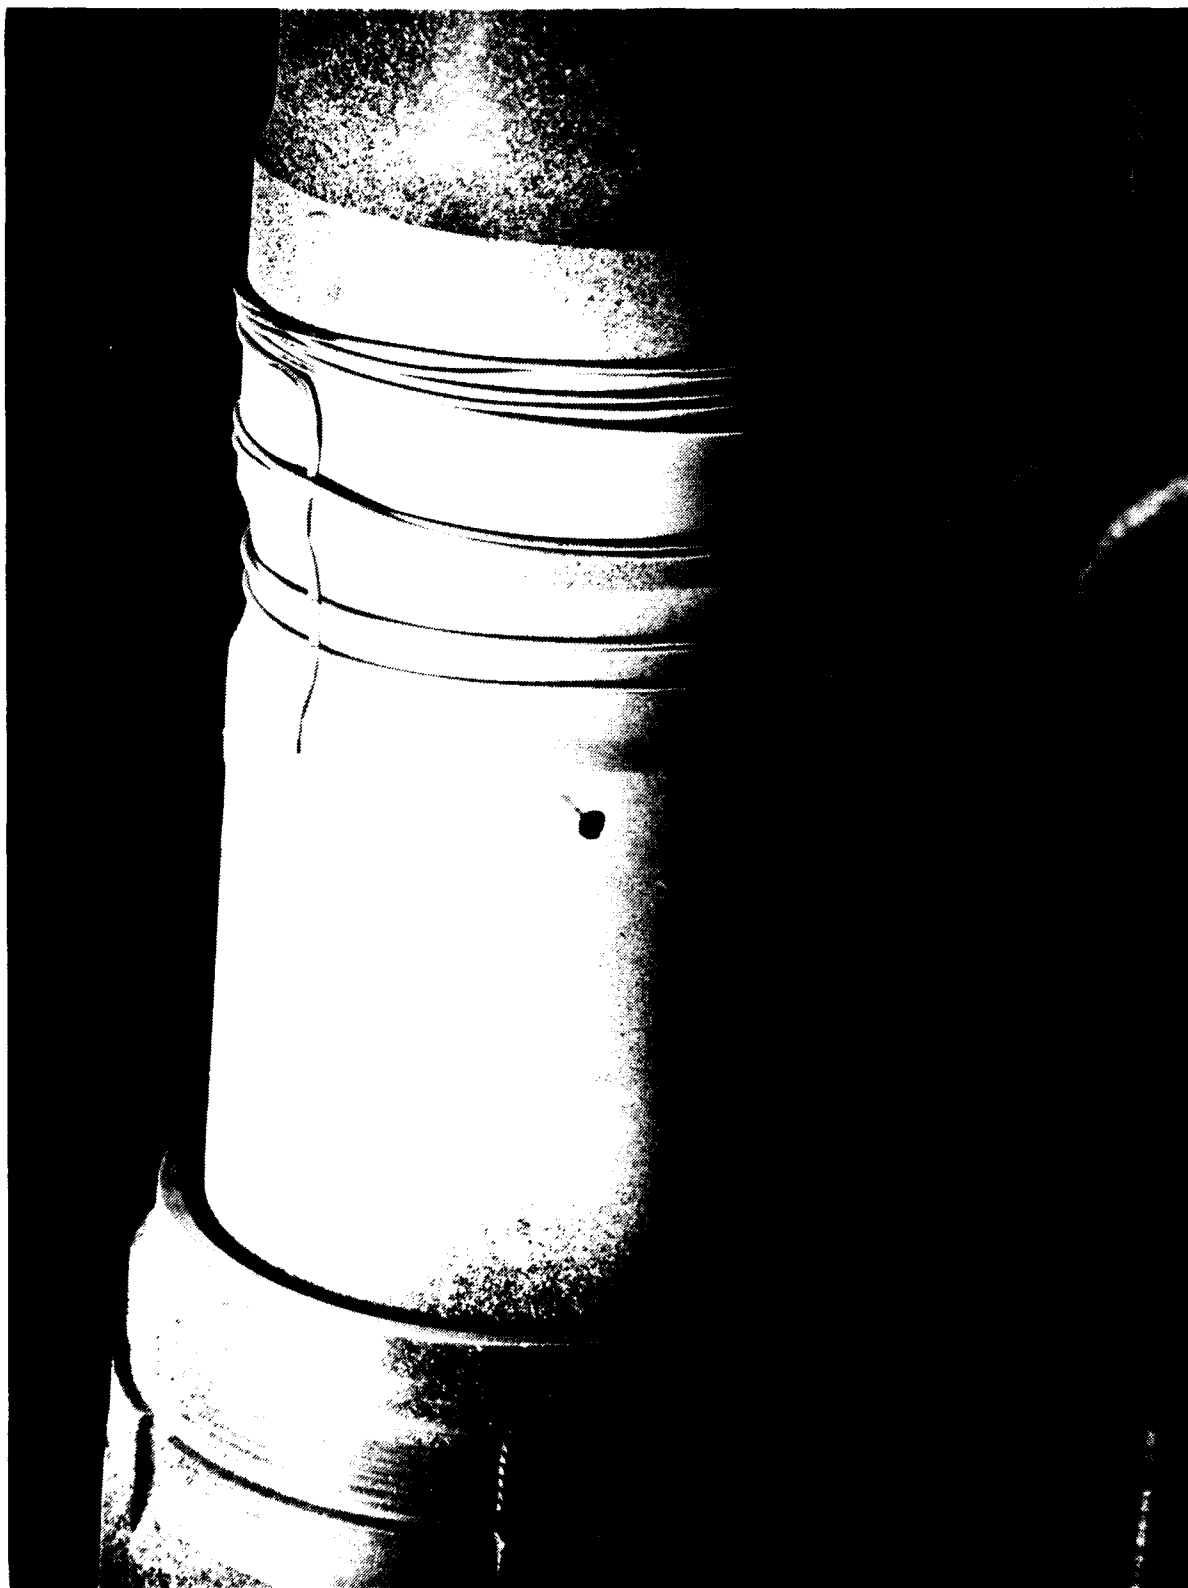
Fig. A-3. Hole 'C'-crack progressing in the aft direction; approximately 1/4 in. long. 61,864 major cycles. (Part 1 of 2)

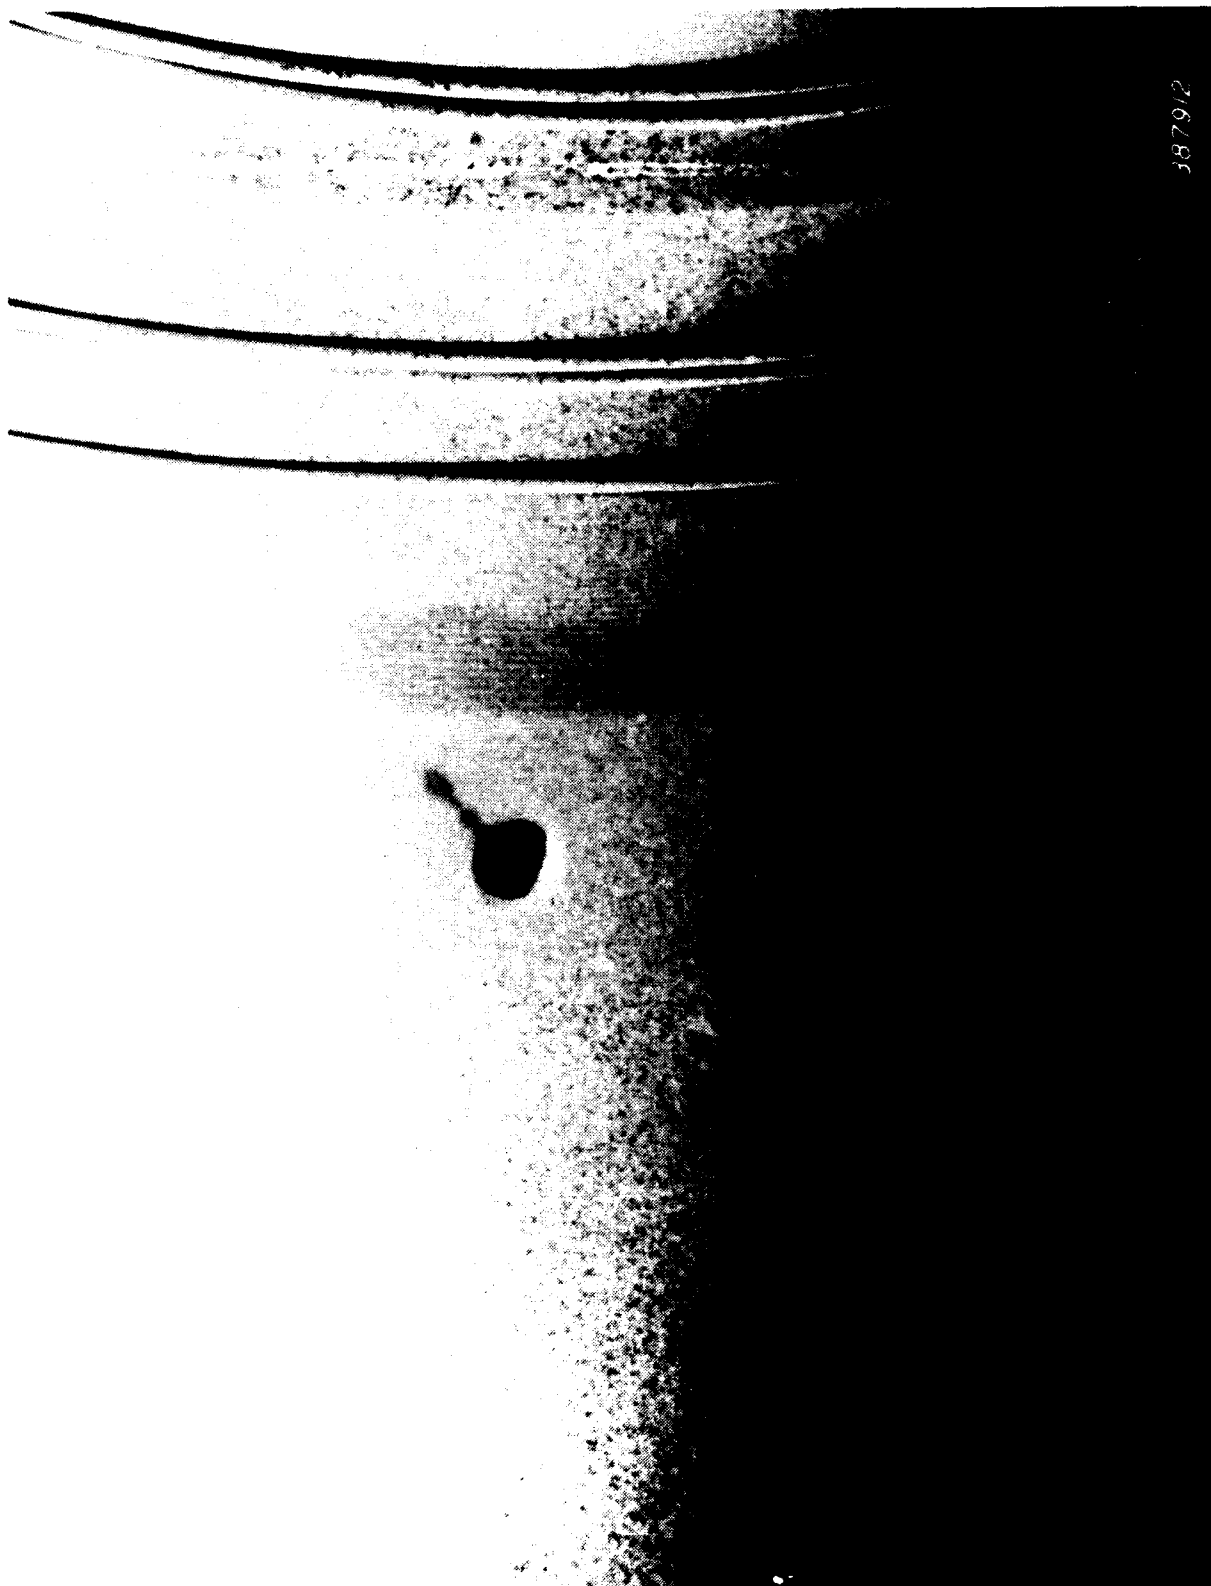
Fig. A-3. Hole 'C'--crack progressing in the aft direction; approximately 1/4 in. long, 61,864 major cycles. (Part 2 of 2)

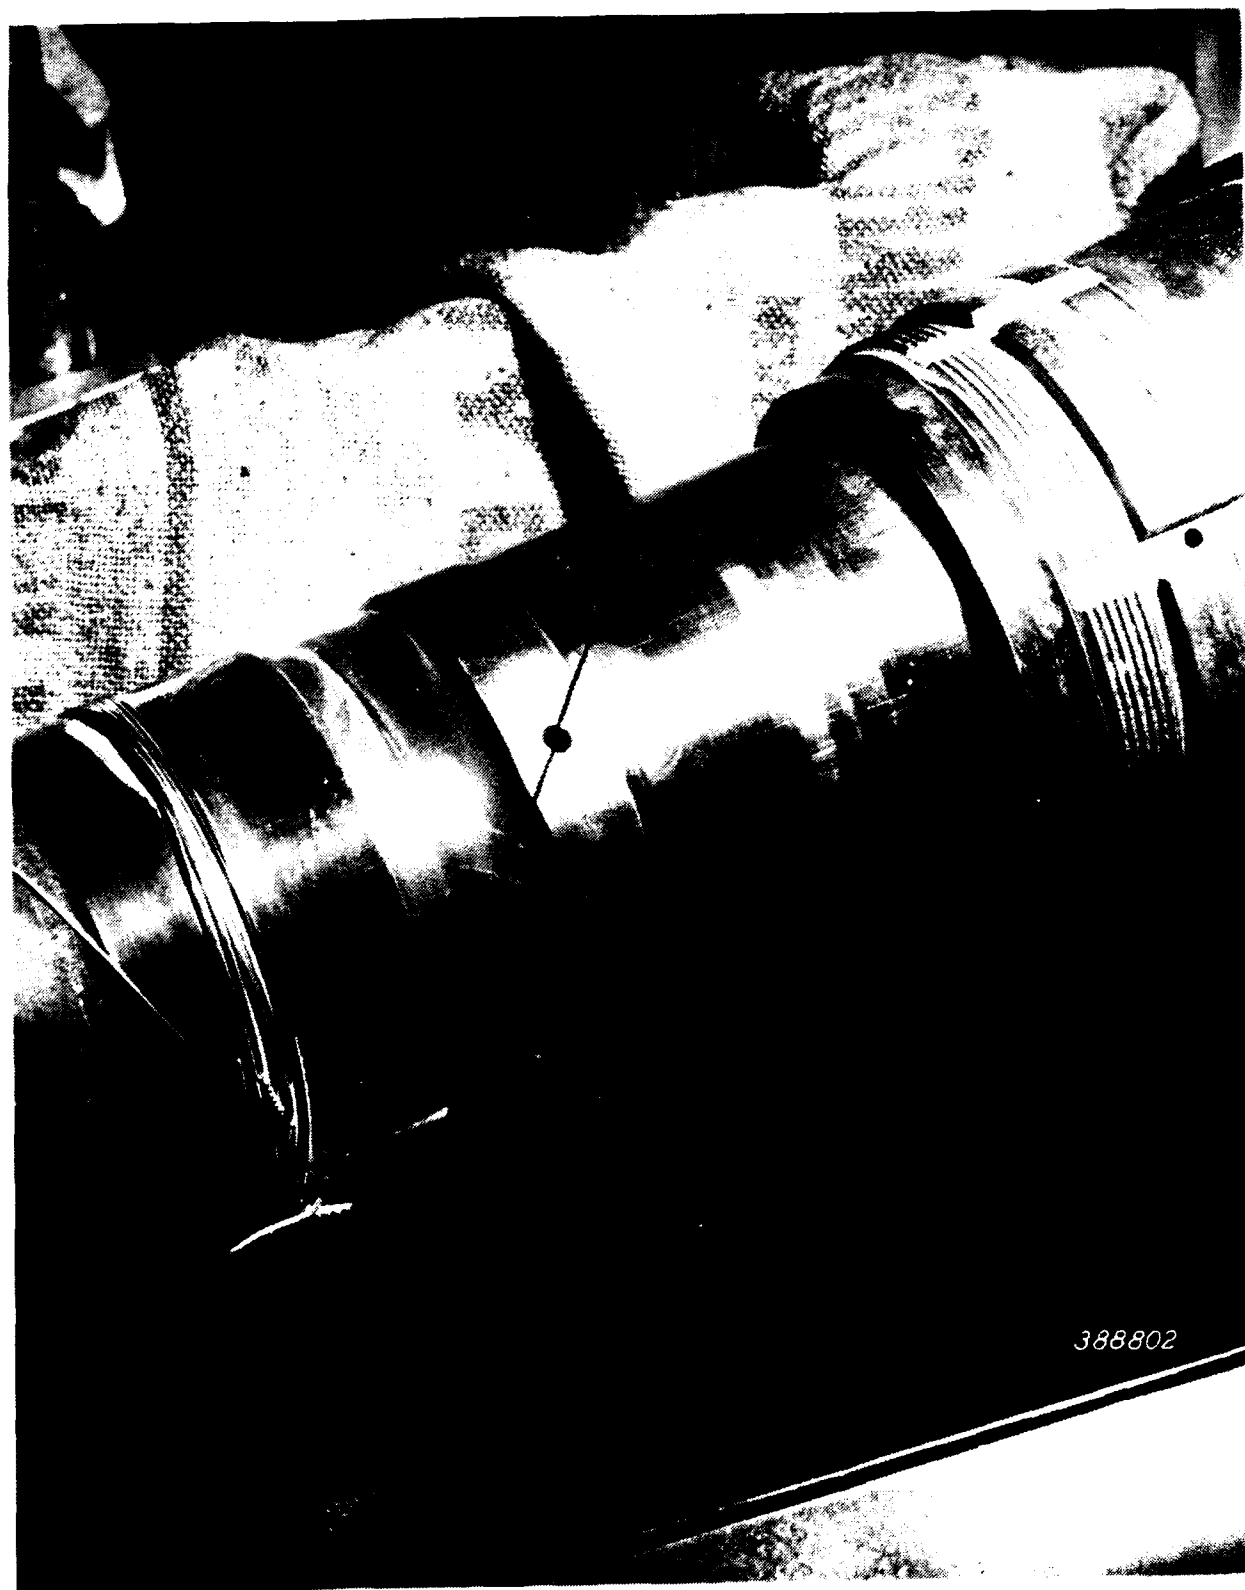
Fig. A-4. Hole 'A'--crack progressing fore and aft; 75,540 major cycles.

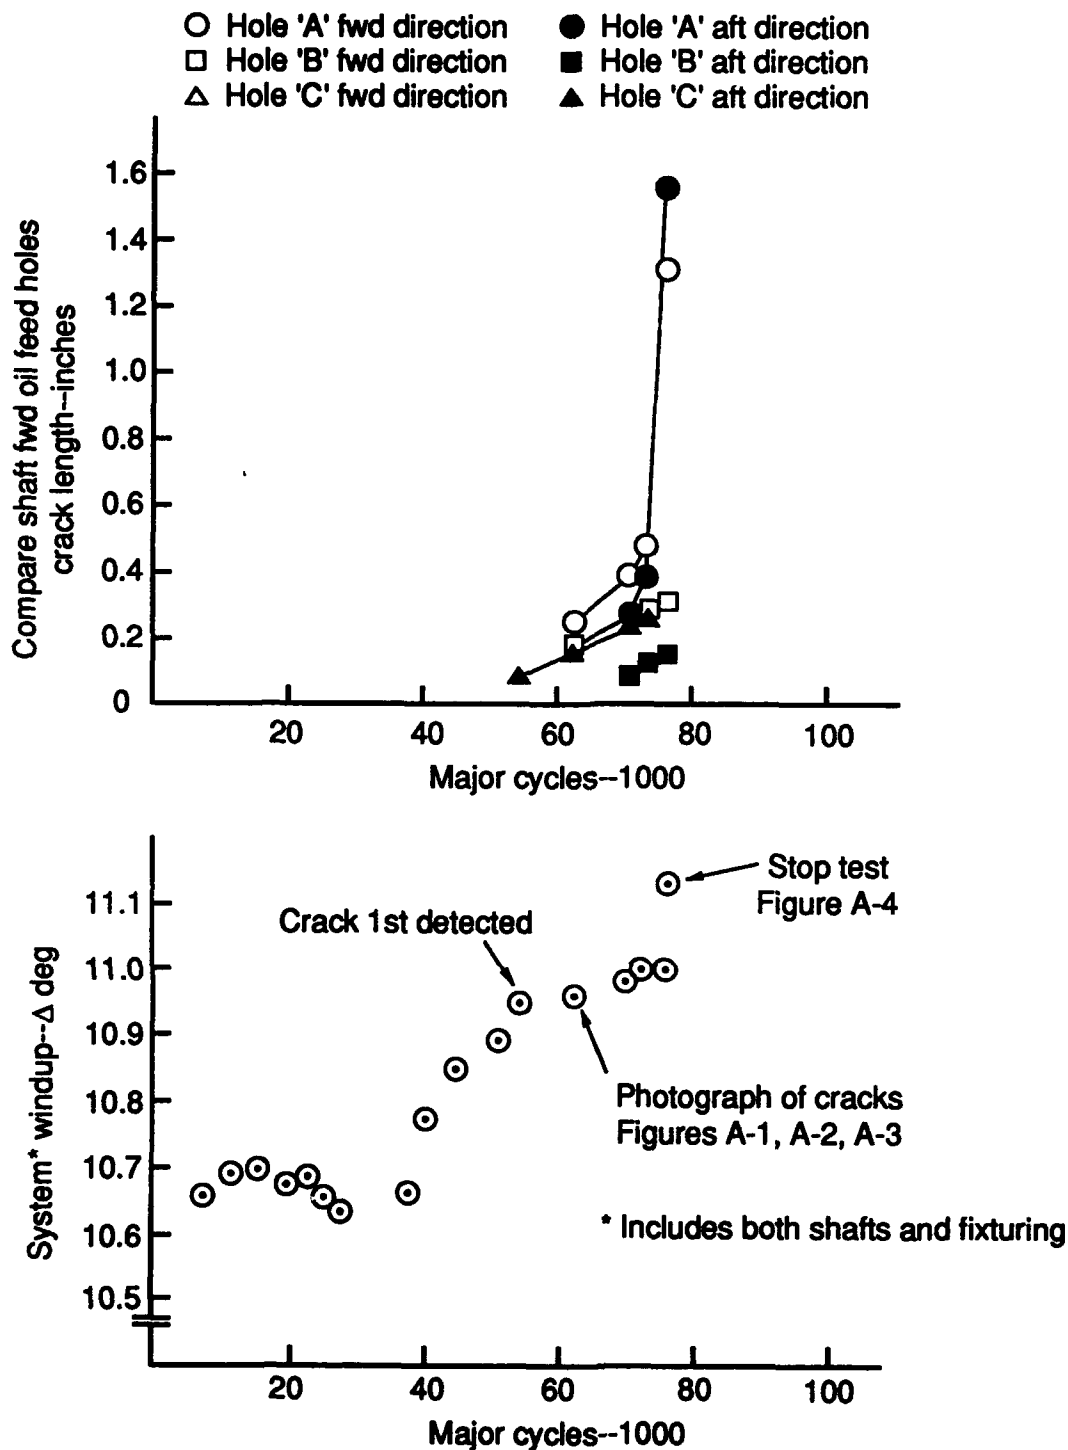
Fig. A-5. TF41 LP mainshaft LCF torsion (TC 875)—compressor shaft 686,006, DN0092, 3434 serv. hr. not B.B.; turbine shaft 6878261, KK11636, 2021 serv. hr, B.B.
